# **Distribution Construction**

## **Inspection Findings**

New England Pipeline Safety Seminar  
October 20, 2010

Karl Baker – CT DPUC  
Gary Kenny – ME PUC

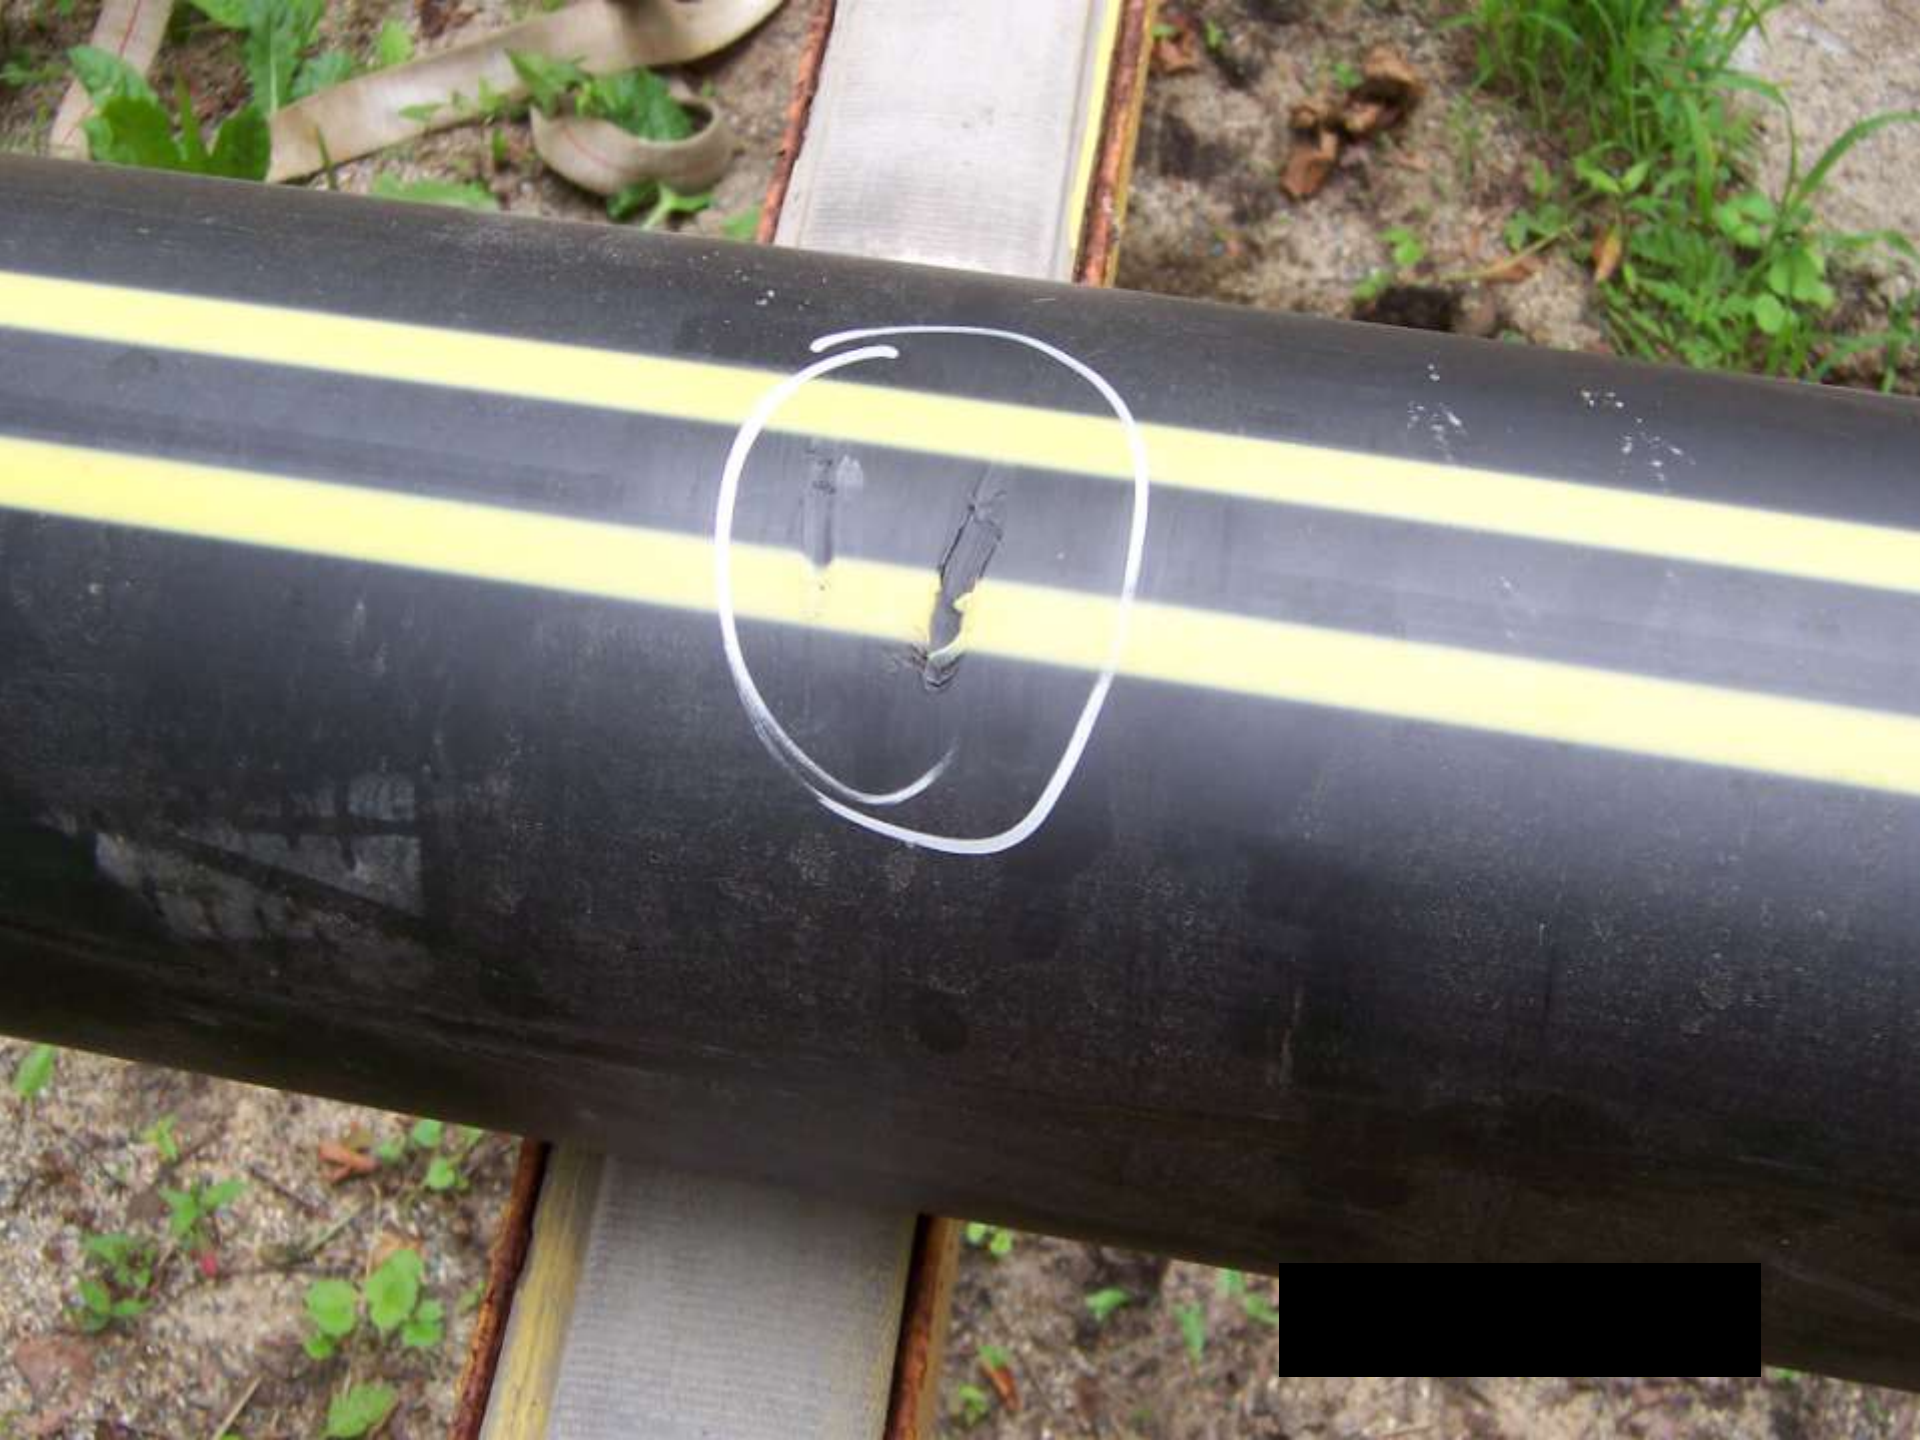
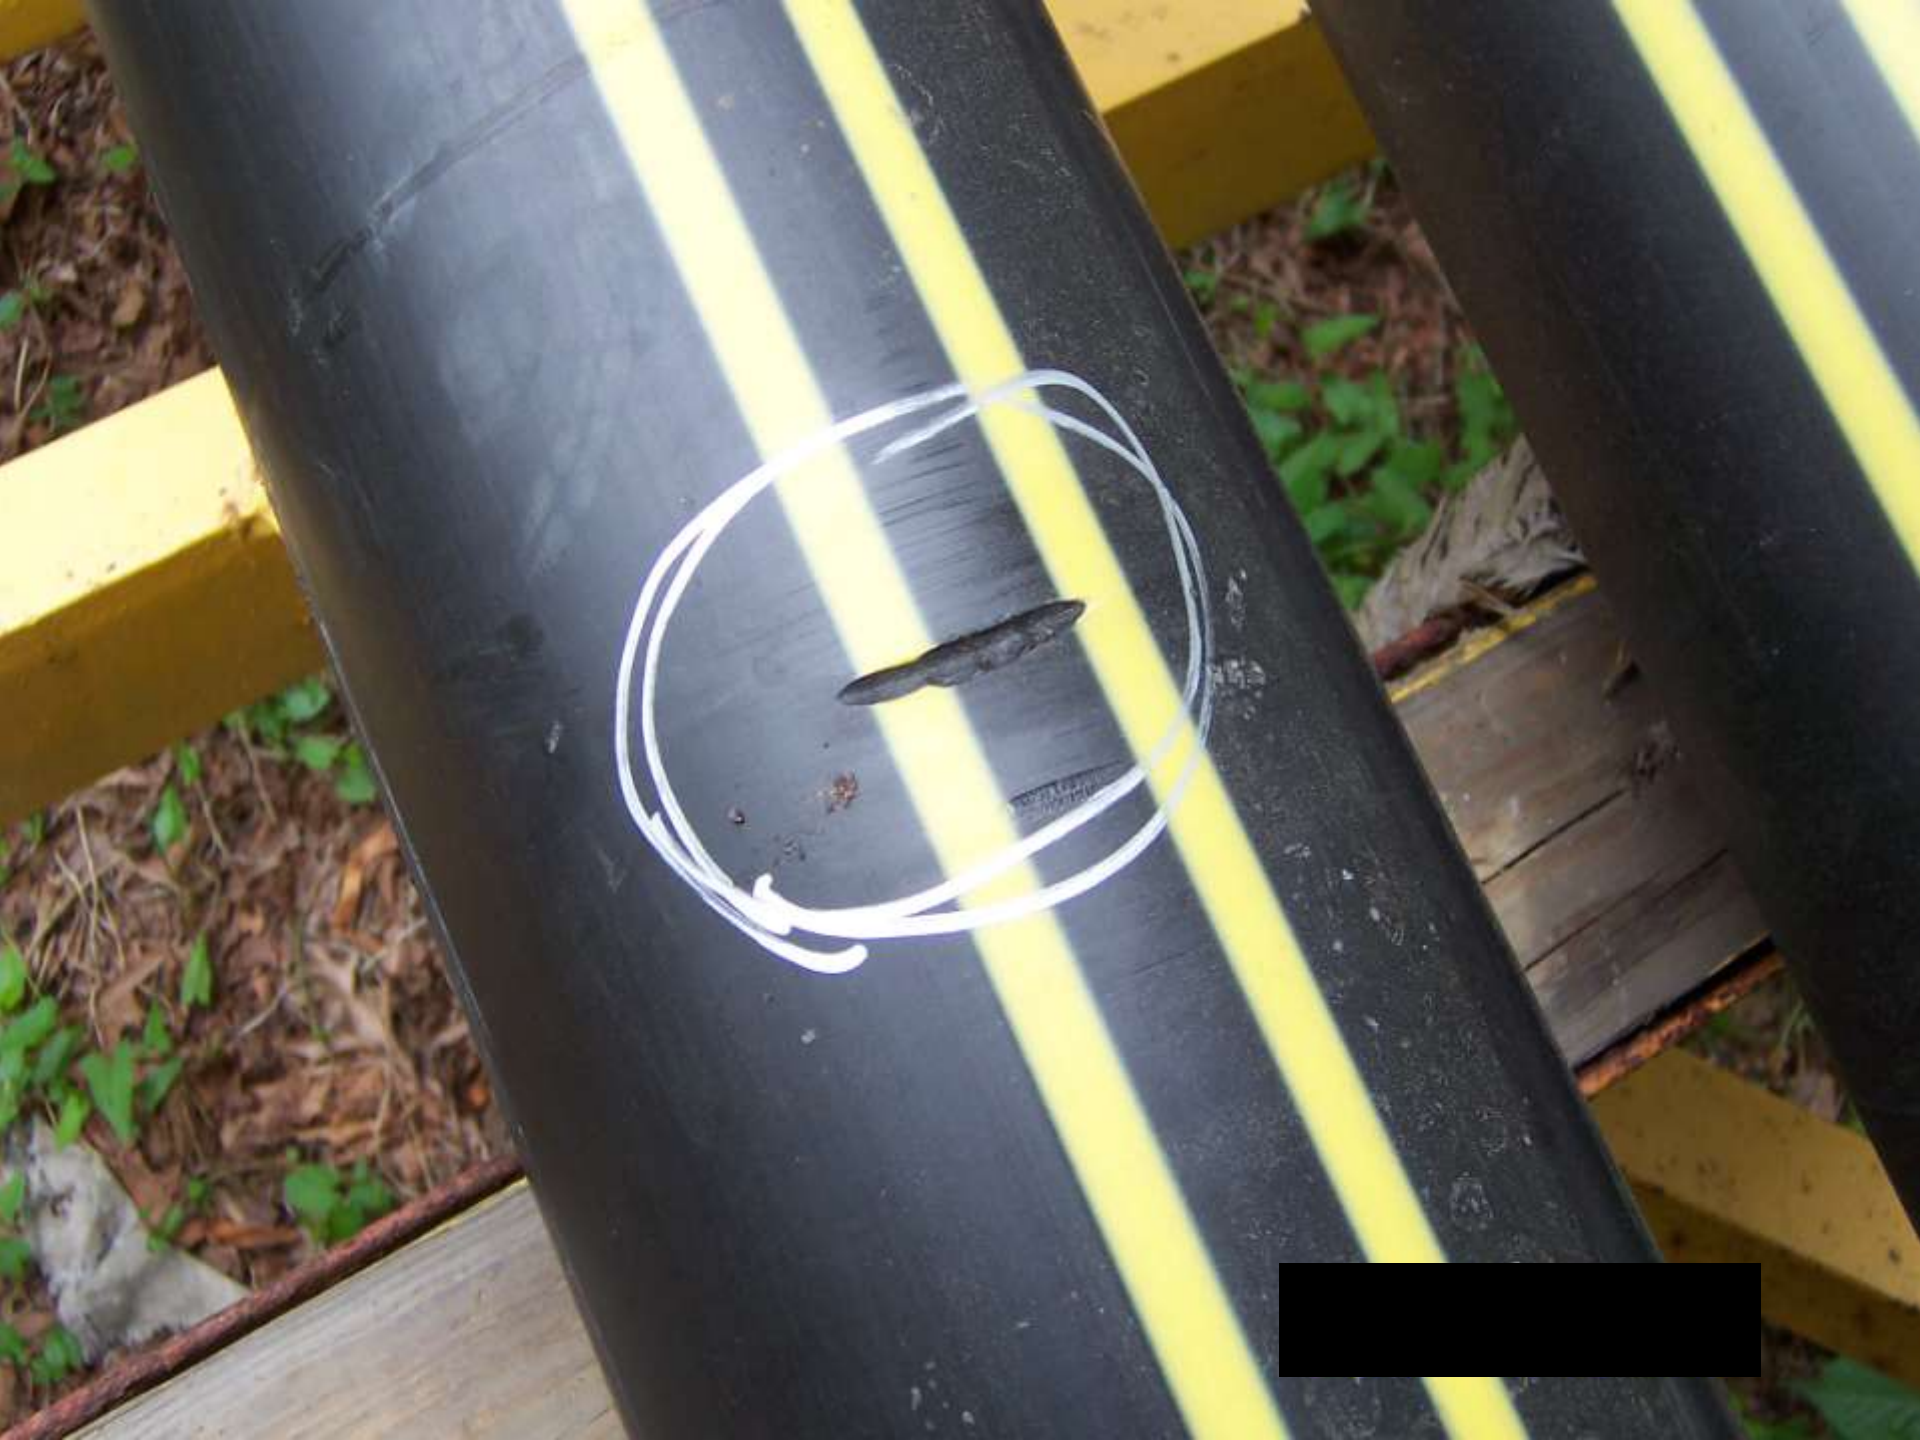
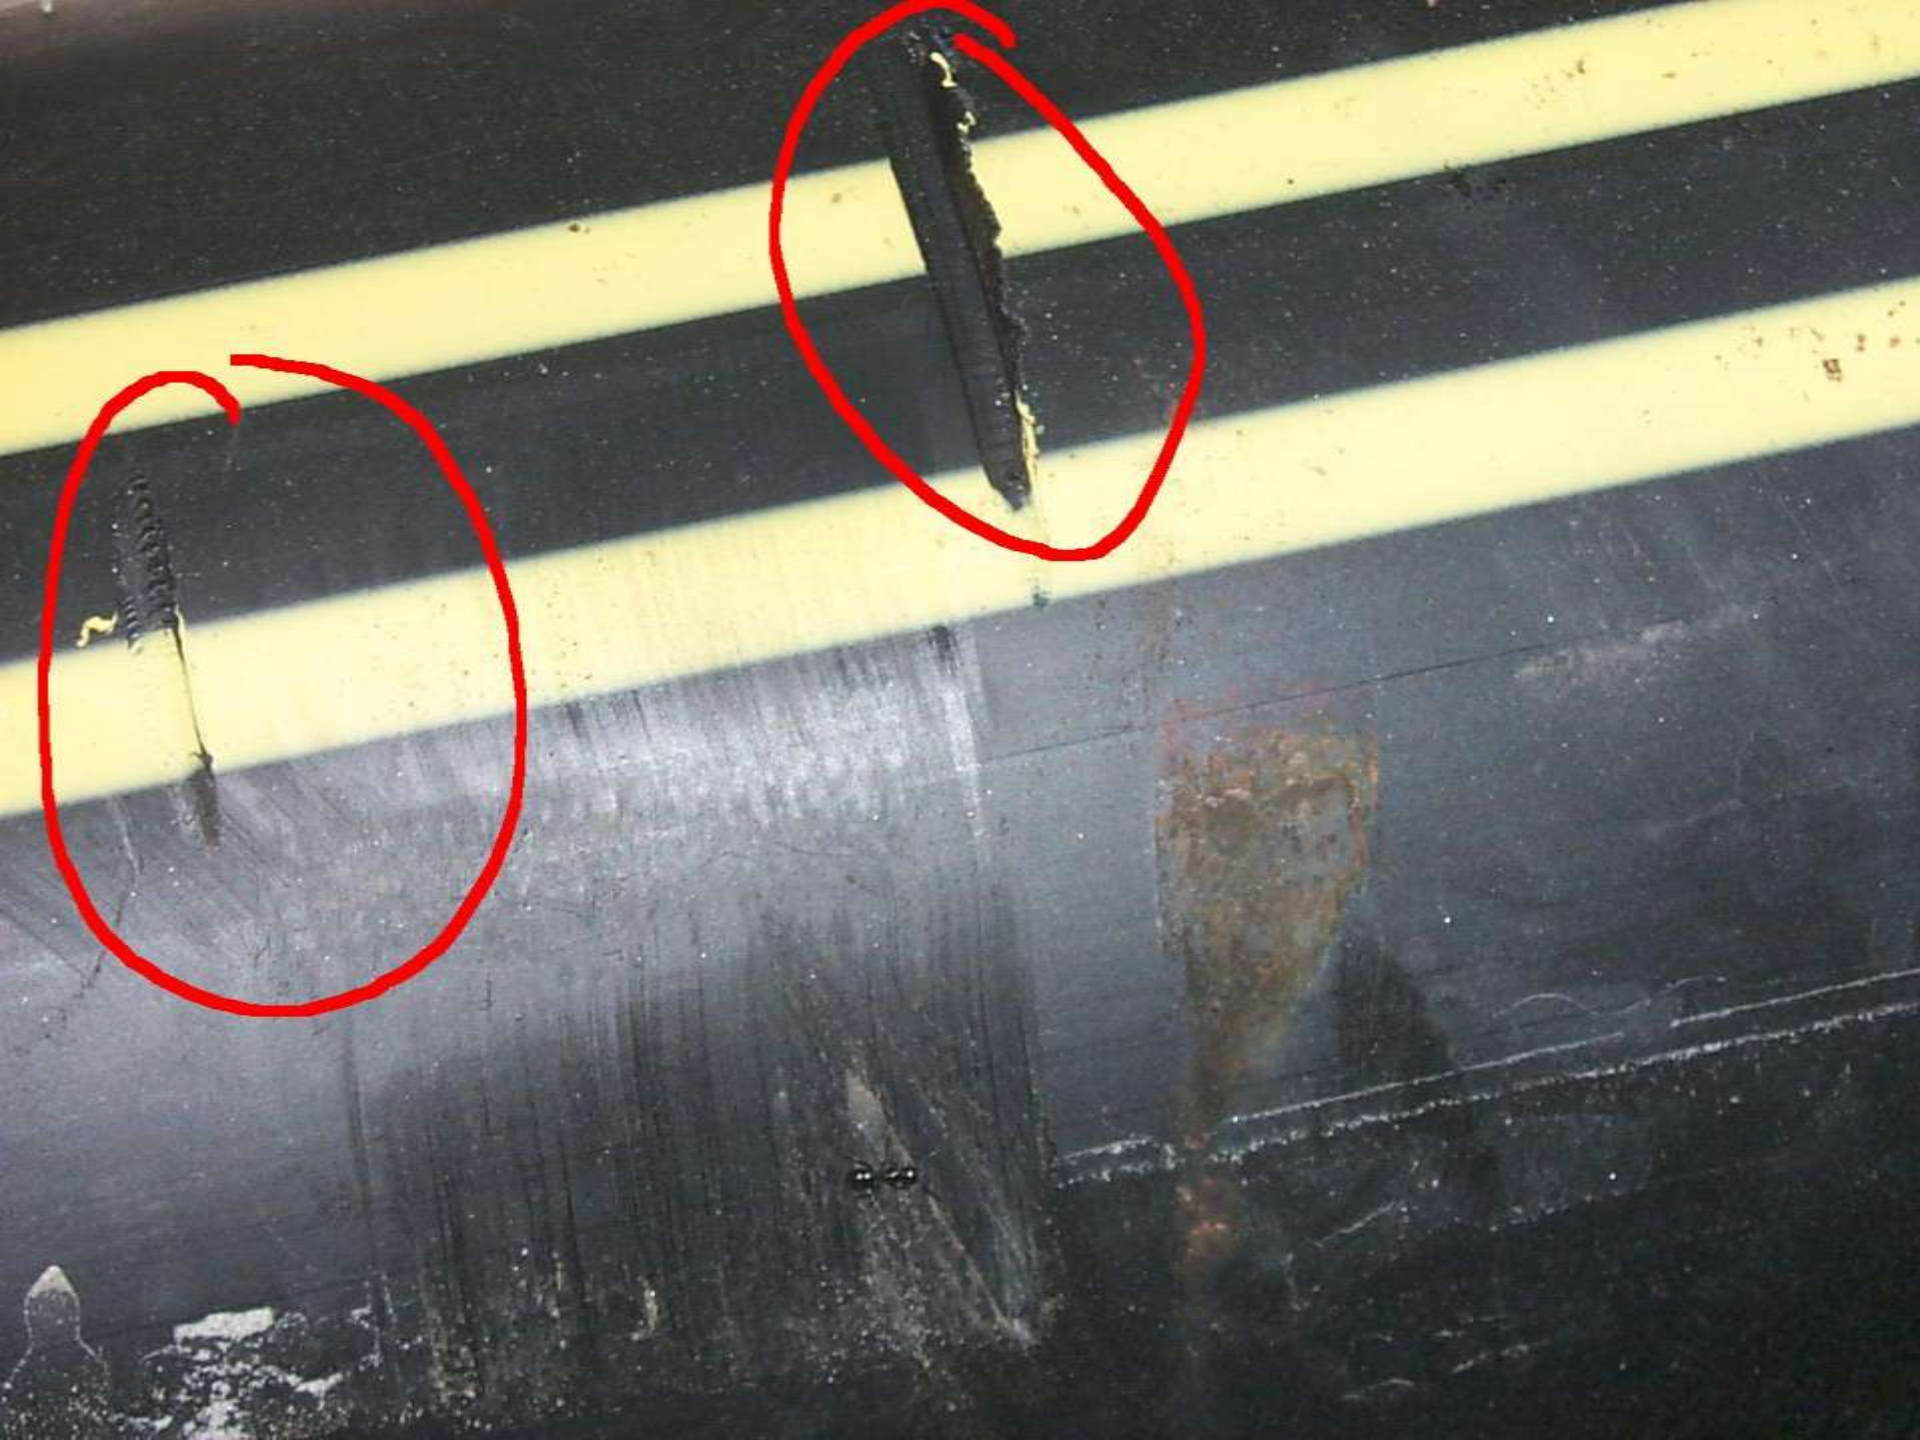
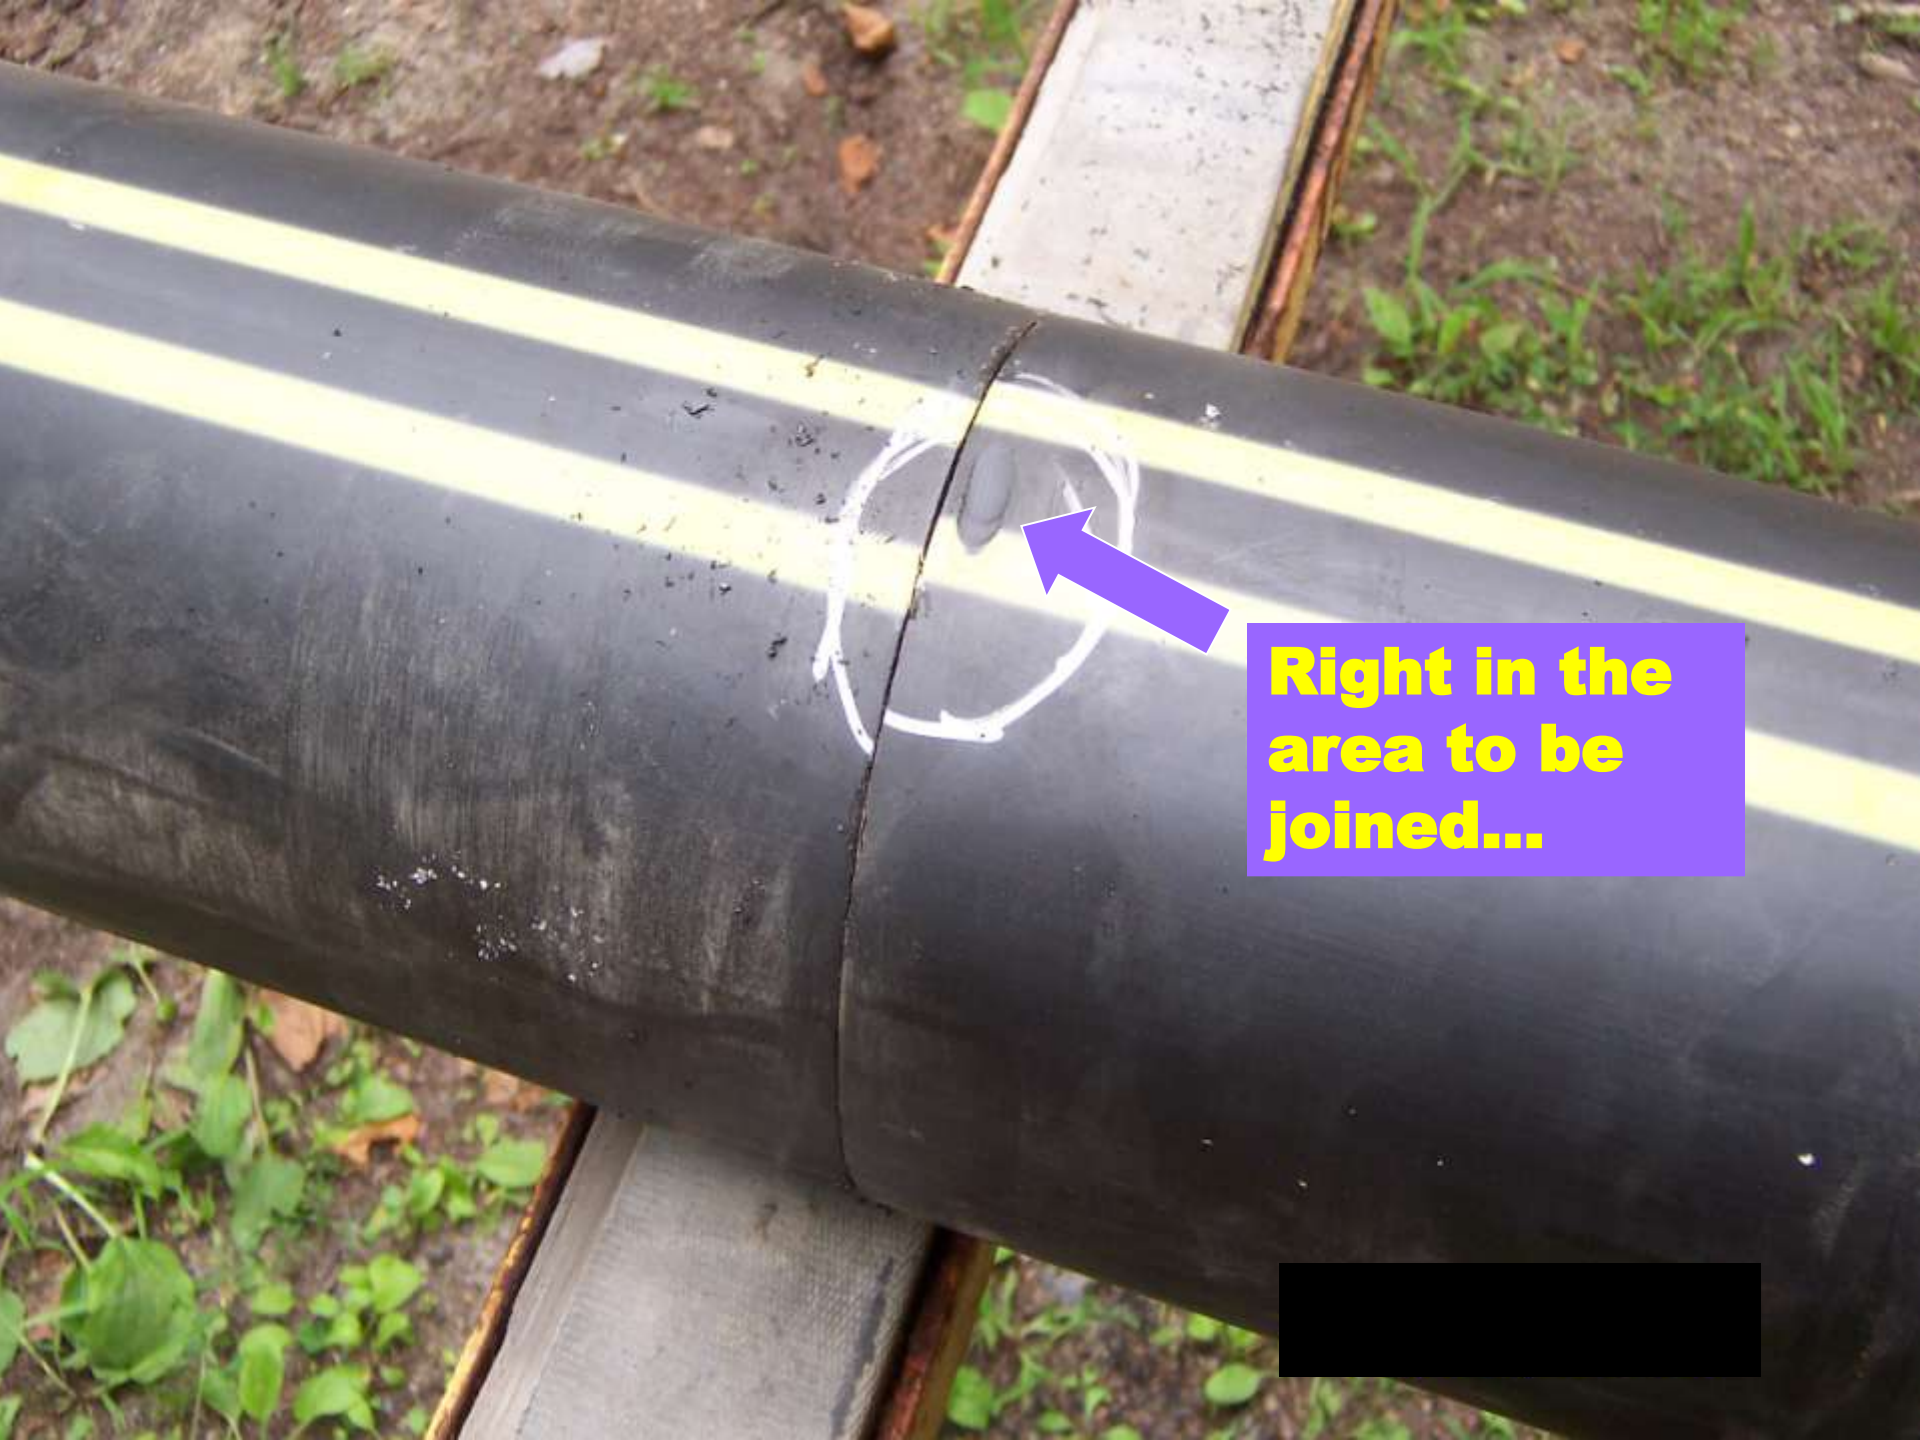
**...if it is free of visible defects.**

**Right in the  
area to be  
joined...**

Each imperfection or damage that would impair the serviceability of plastic pipe must be repaired or removed.

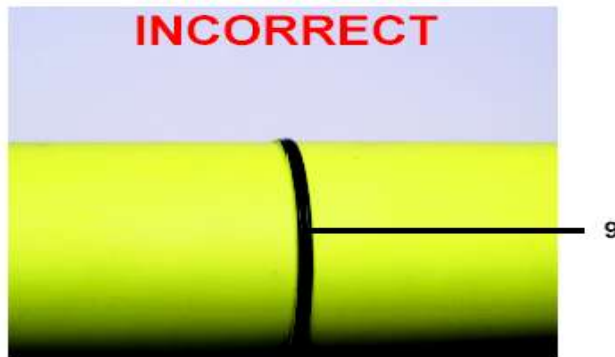
9. Insufficient heat time; melt bead too small

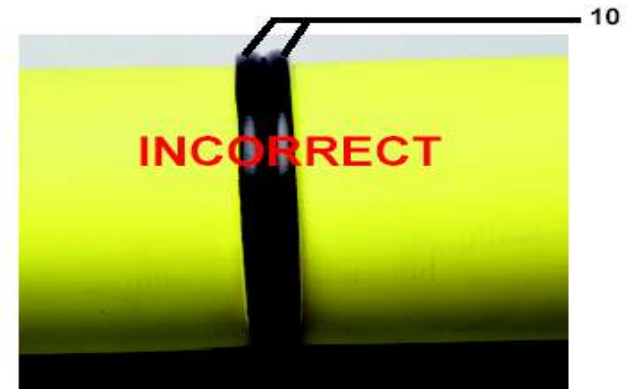
10. Excessive heat time or pressure applied during heating; melt bead too large

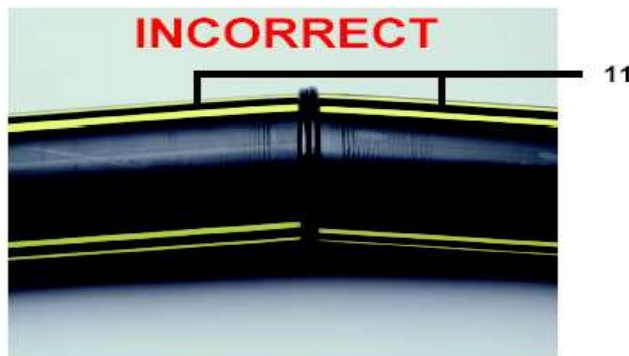
11. Pipe angled into fusion unit

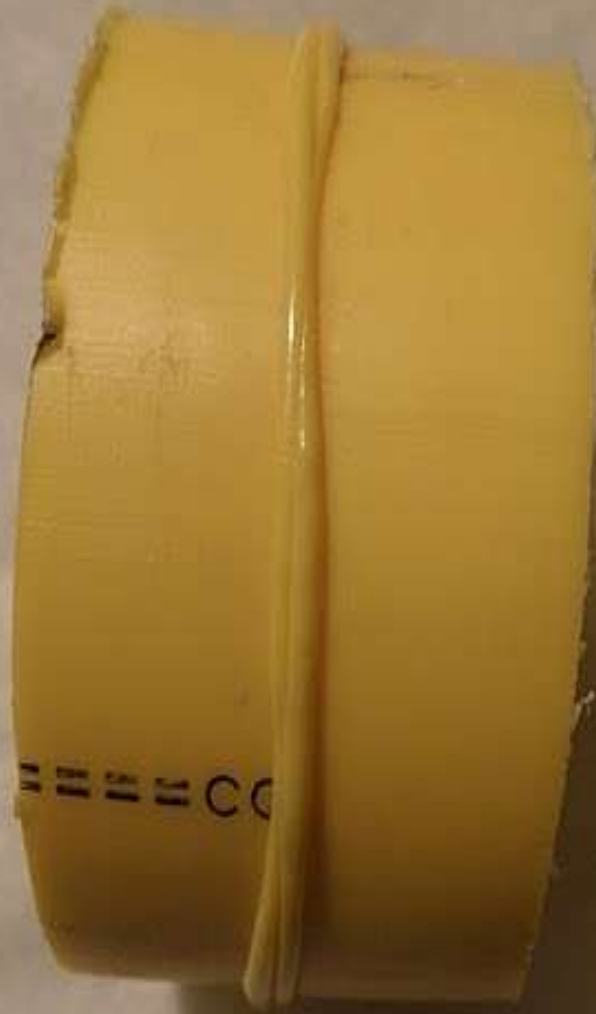
# Factory Tapered Ends

- ▶ **An abnormal High-Low is often apparent; especially if both ends are not faced equally, or if a factory end is mated to a cut end.**
- ▶ **Solution: Cut off or face back the factory taper.**

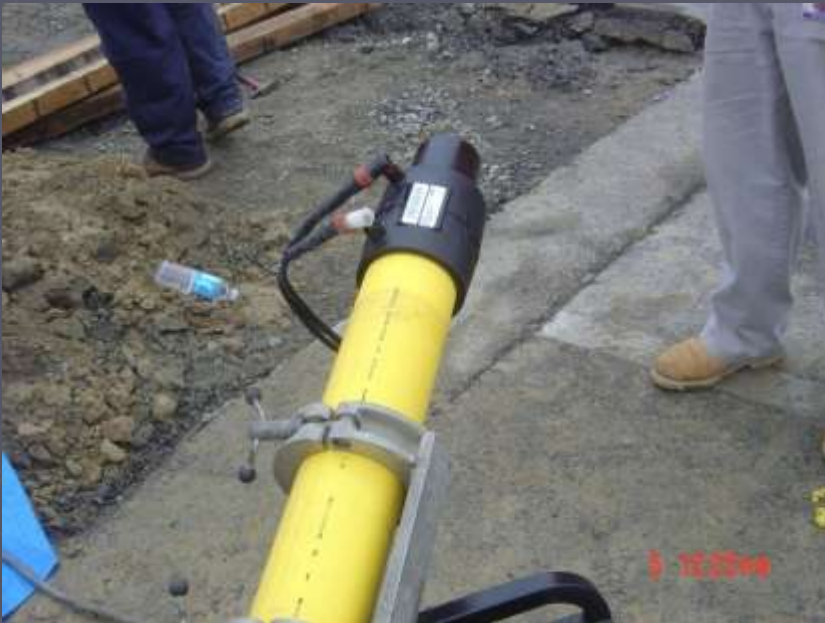
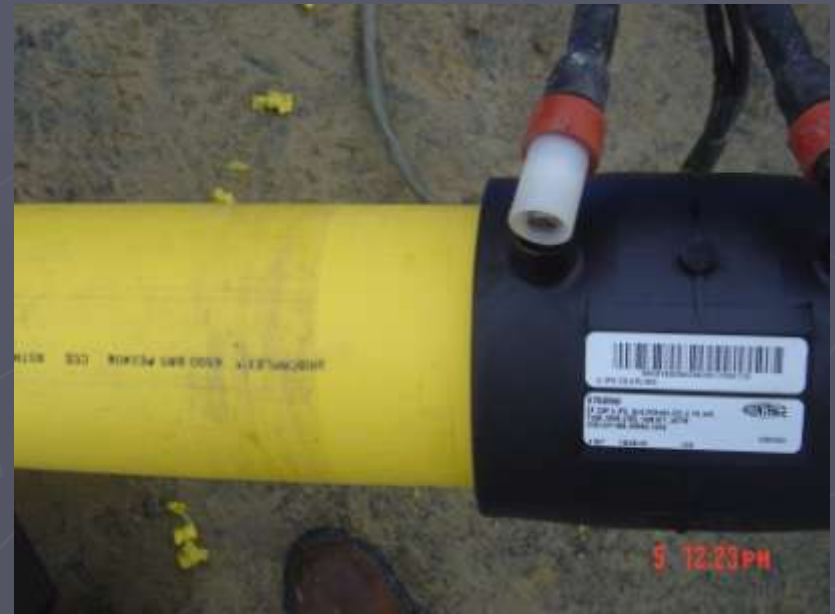
**The Operator did not mark the proper stab depth before performing an electrofusion.**

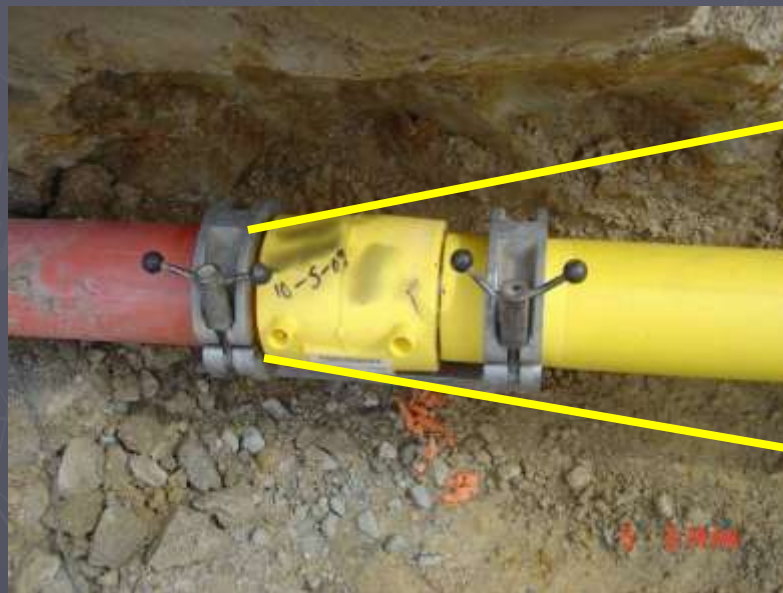
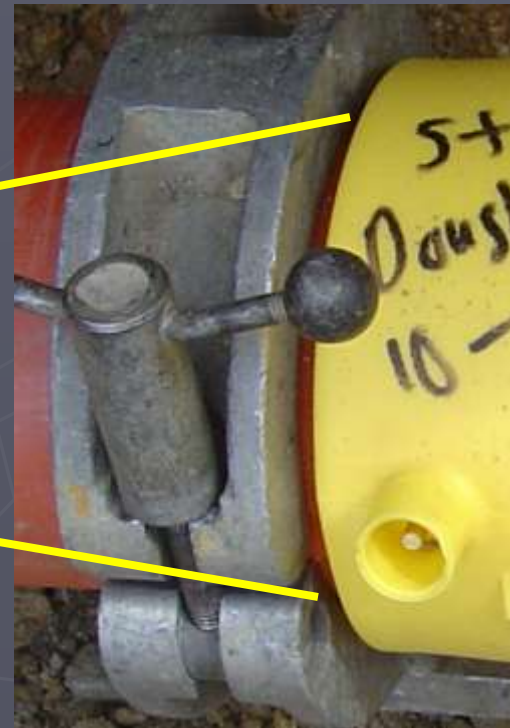
**Another example of not marking the proper stab depth before performing an electrofusion.**

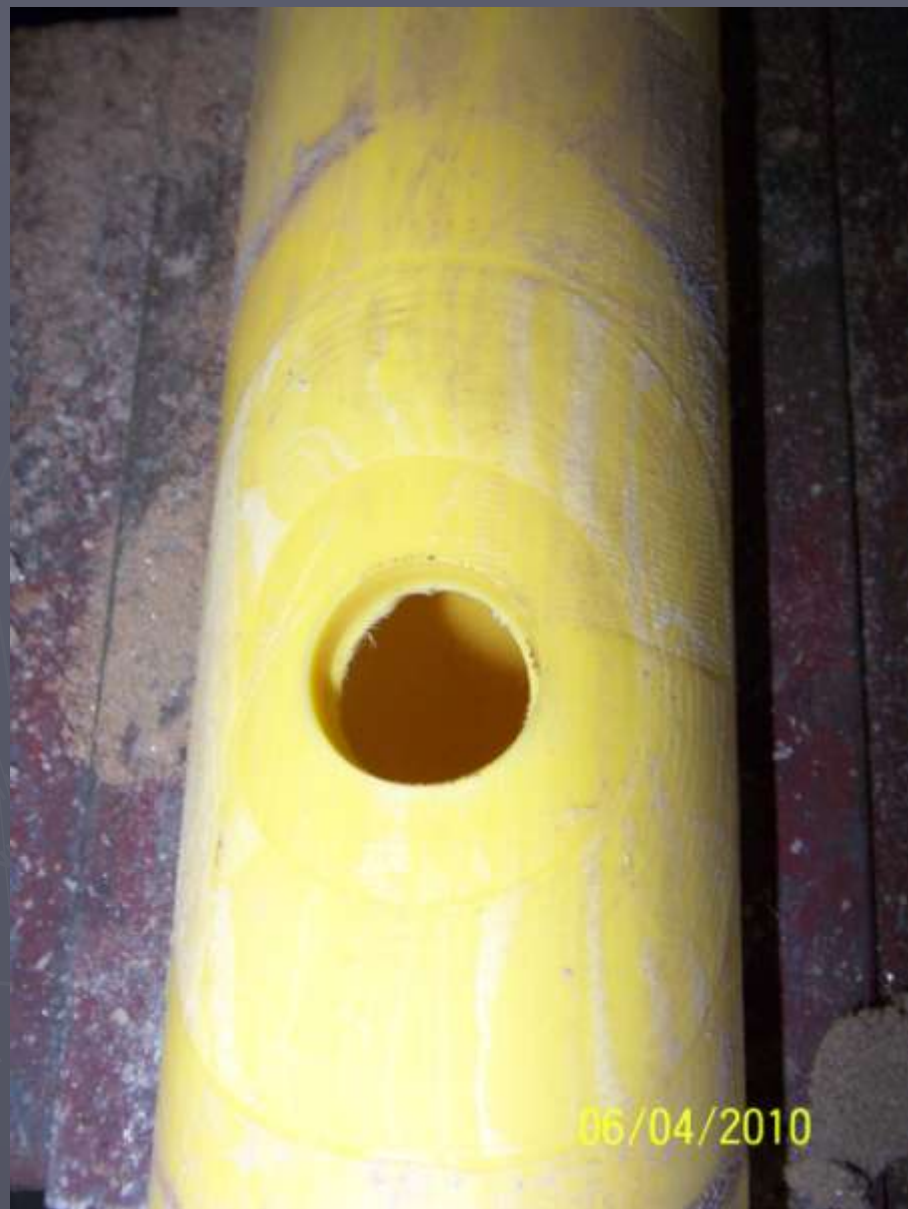
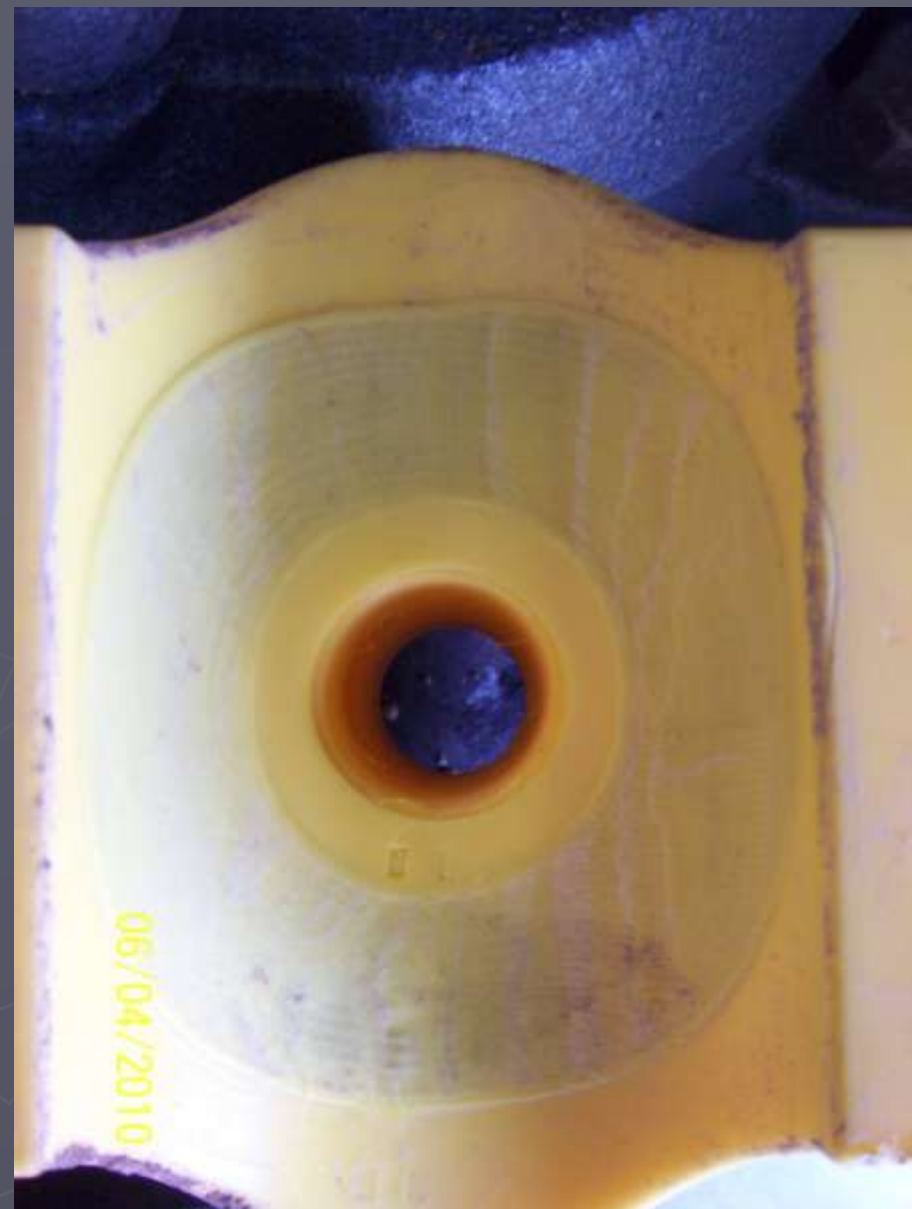
- **During an inspection of electrofusion tees, the inspector was concerned that the pipe was not scraped at all**
- **Later determined that a minimal amount of scraping had occurred**
- **Destructively tested 6 joints of concern – 5 failed**
- **Excavated many electrofusion joints**
- **Paint scrapers no longer allowed**

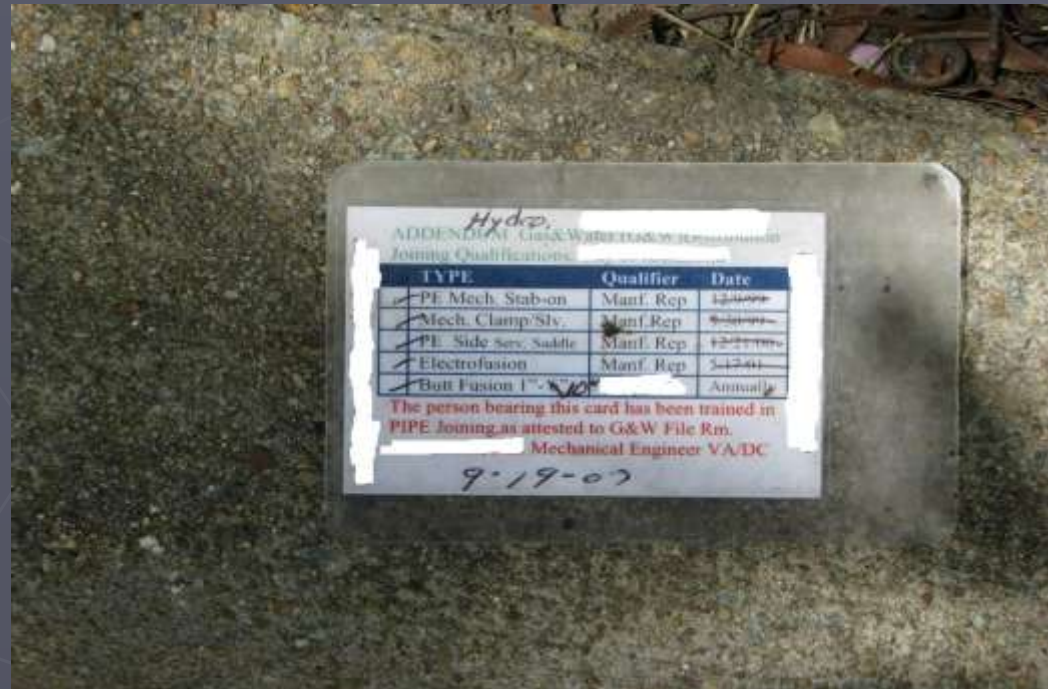
- **The Operator's contractor performing heat fusion had an expired joining card.**

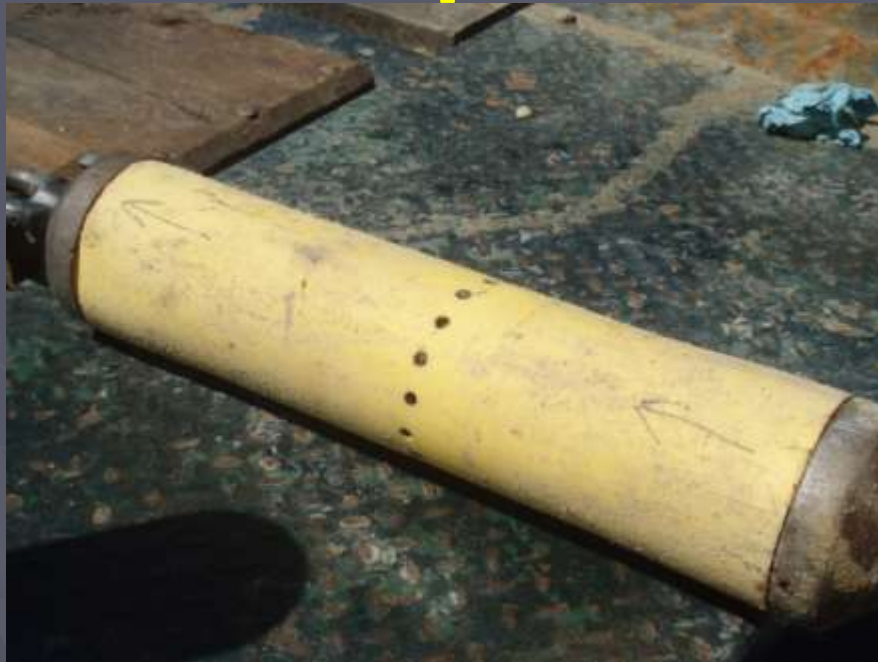
**Calculated Weakened Pipe**

- ▶ **The GPTC Guide for Horizontal Directional Drilling for Plastic Pipe recommends a weak-link or breakaway device if the Allowable Tensile Load (ATL) of the pipe can be exceeded.**
- ▶ **The ATL can be calculated with ASTM F1804 and the formula is also provided by many pipe manufacturers.**

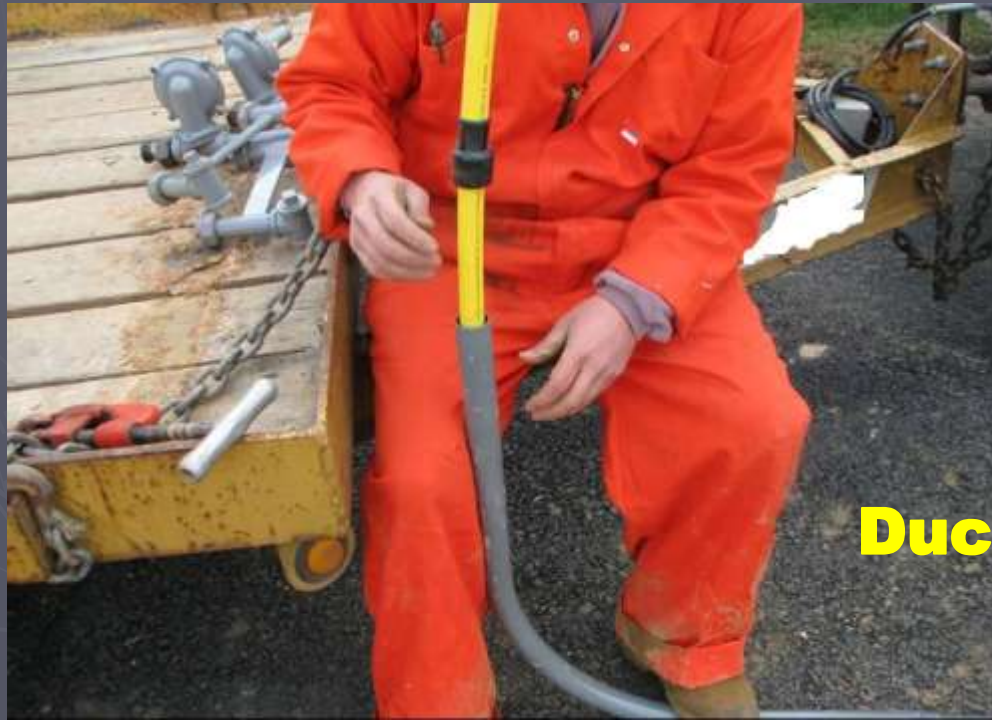
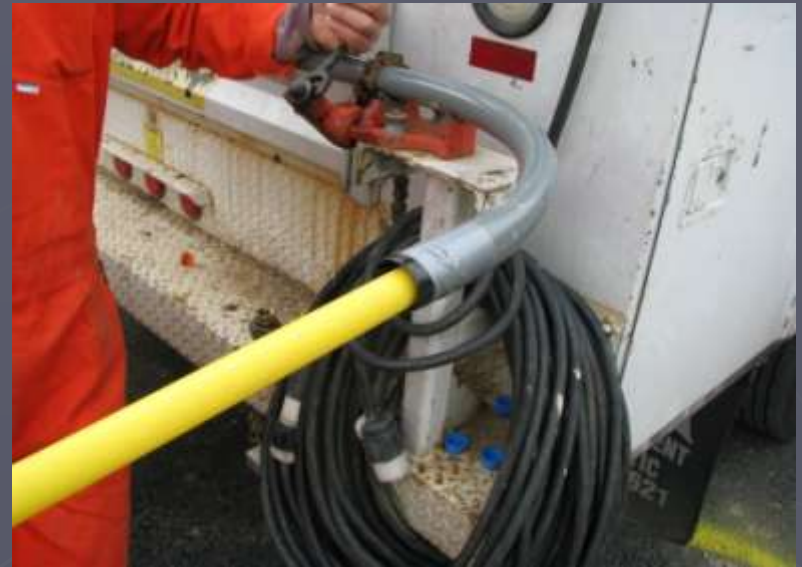
# MacGyver?

## **Case study:**

- ▶ **The Operator's contractor performing a branch service installation shortened two anodeless risers. There was no procedure for this activity.**

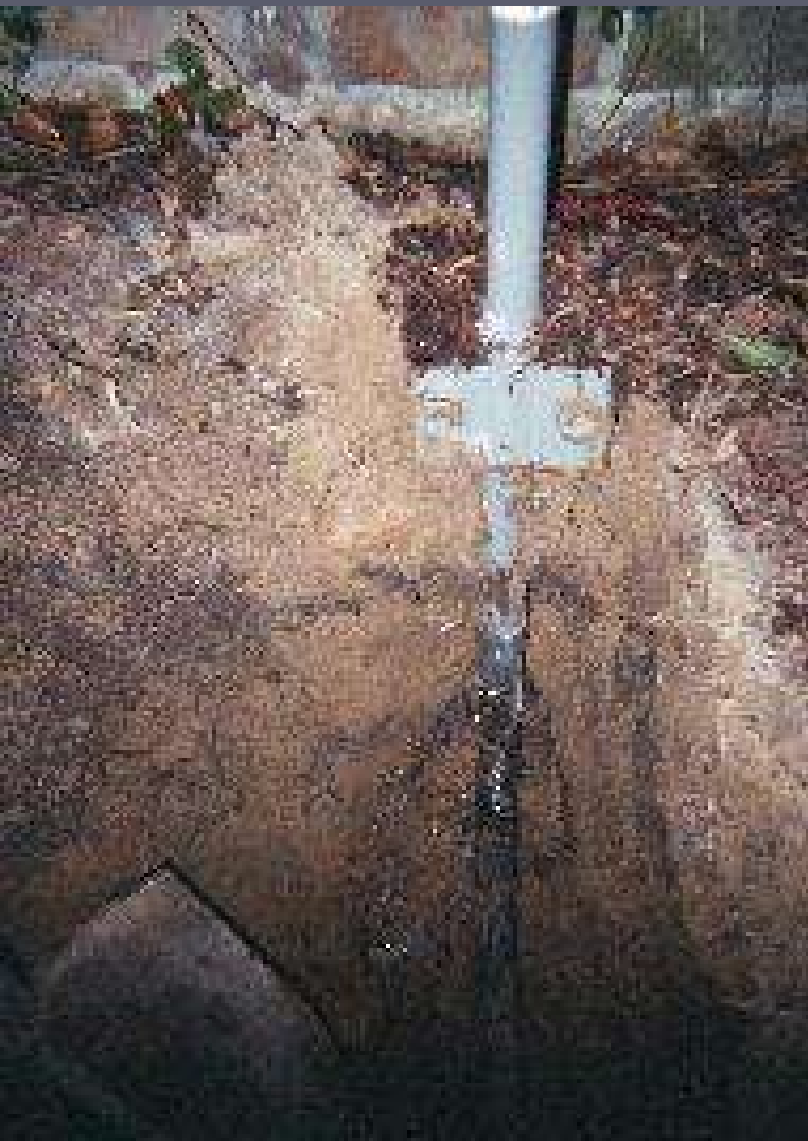
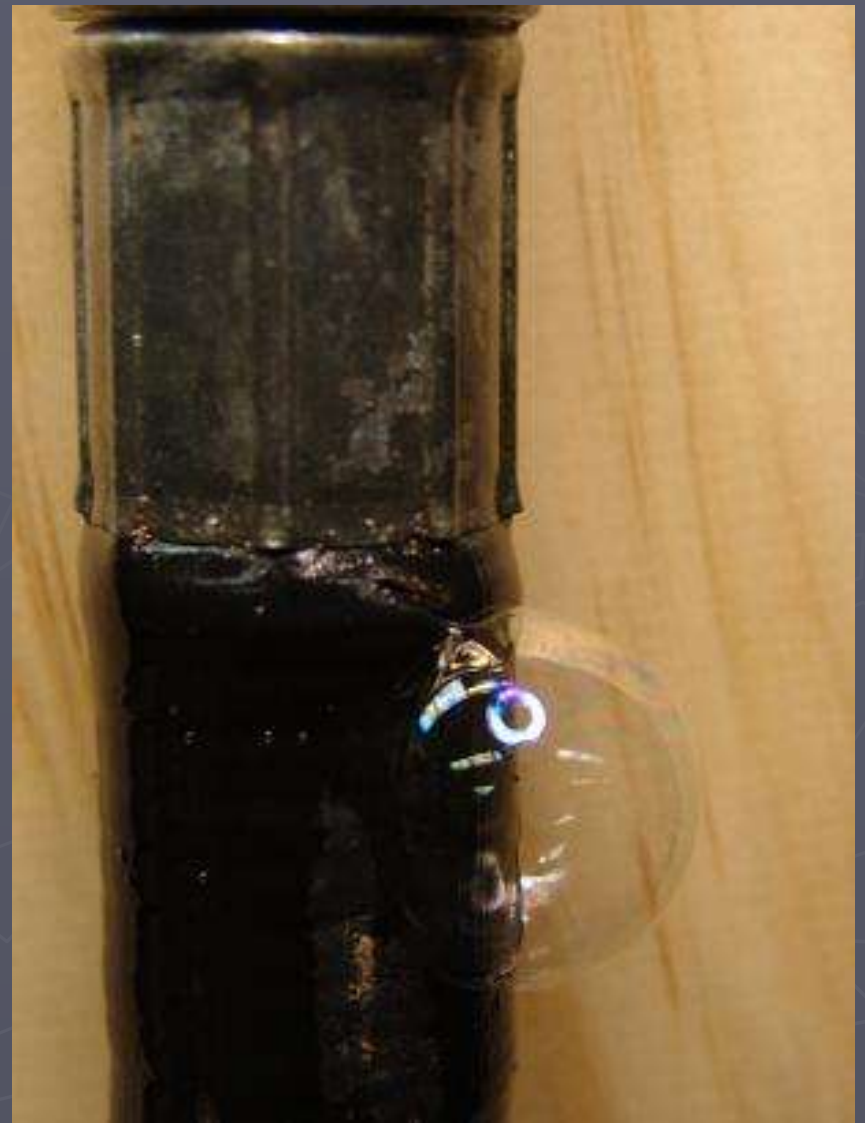
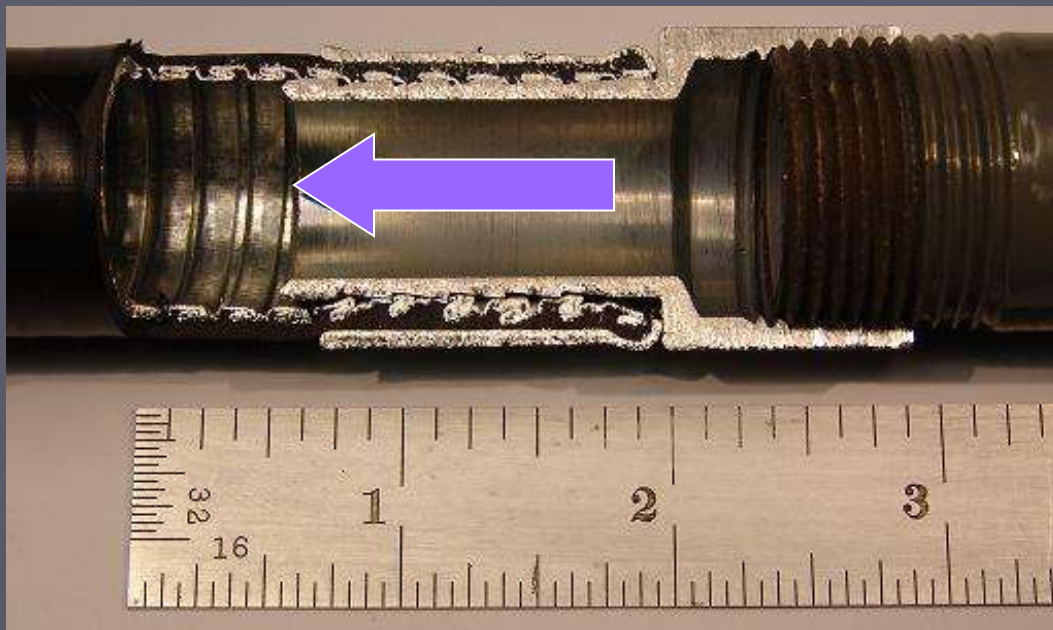
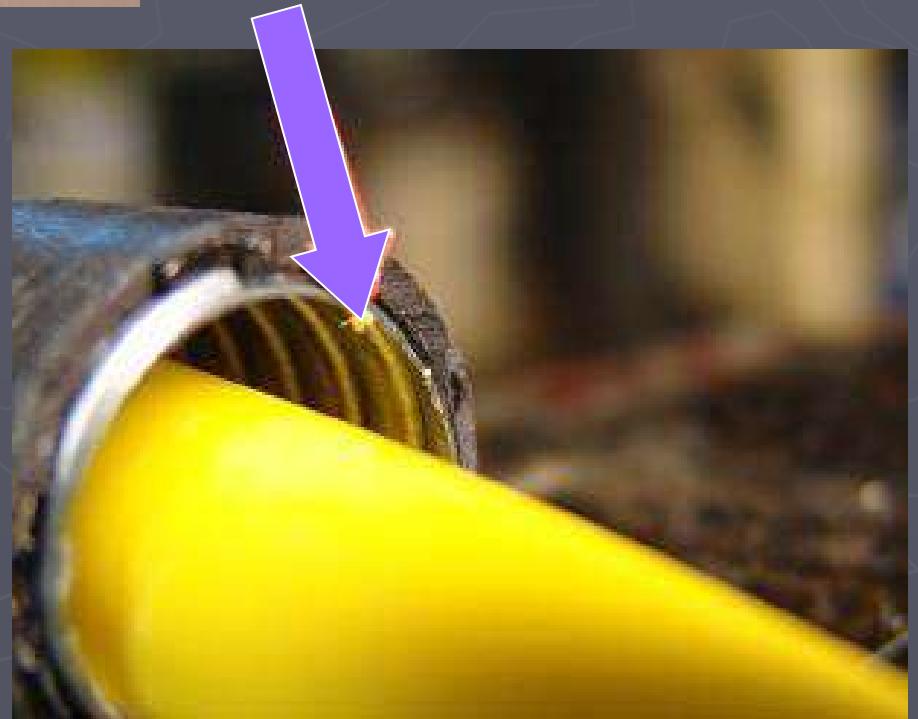
- **This time the Operator had a written procedure to assemble anodeless risers but unfortunately the parts supplied were leading to on site failures.**

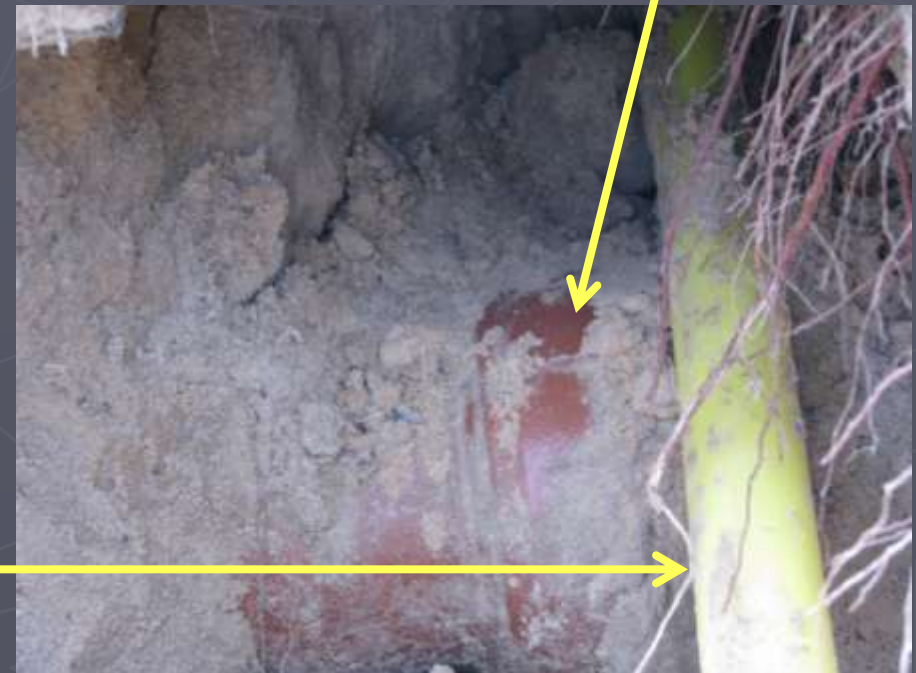
**§192.325(b) - Failure to install a main with enough clearance from any other underground structure to allow for proper maintenance**

**Electric Line**

**Sewer Line**

**2" Plastic Gas Main**
